Production of 171 pcs. micropiles for a deep foundation as part of rebuilding of commercial/residential estates in the city center of Aalborg

# Commercial and residential estates, Aalborg

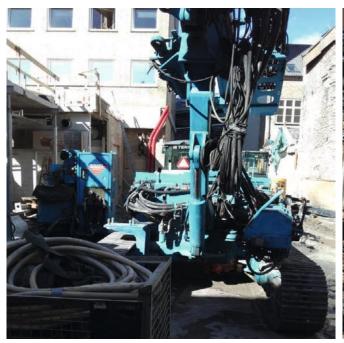
Our drilling rigs type KR-802 and KR 803 were ideally equipped to tackle these challenges (Image 2). We were even able to use a double-casing drilling system to control backflush and prevent softening of the water-sensitive building grounds. Steel bars were installed in 6,0 m lengths by excavator.

Image 2: Klemm KR -803

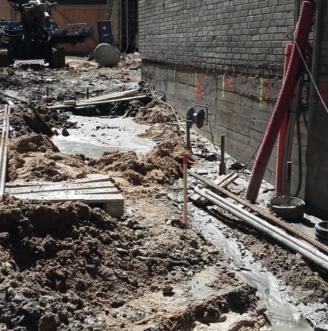
Disposal of backflush was accomplished with mud pumps leading the material from the drill point into mud containers. Drilling works were slightly complicated by residual foundations and boulders that had to be removed or perforated with specialty drilling tools. In some areas, vertical plastic pipes were placed as a drill guide so to prevent damage of power cables (Image 3).

Image 3: Plastic pipes as a drill guide and conditions on building site
