## Reconstruction of the Bremer Weser-Stadium, Eastern and Western Stands

Deep foundation of the Eastern and Western tribunes inside the Weser-Stadion in Bremen

System:	Gewi-pile / steel diameter 40 and 50 mm
Quantity:	275 pcs. (West tribune), 461 pcs. (East tribune)
Length:	11,50 – 15,50 m
Service Load:	up to 465 kN
Technique:	single head percussive flush drilling
Building Ground:	sand / grit
Time Frame of Works:	March – May 2009 (West tribune), Mai – Juni 2010 (East tribune)

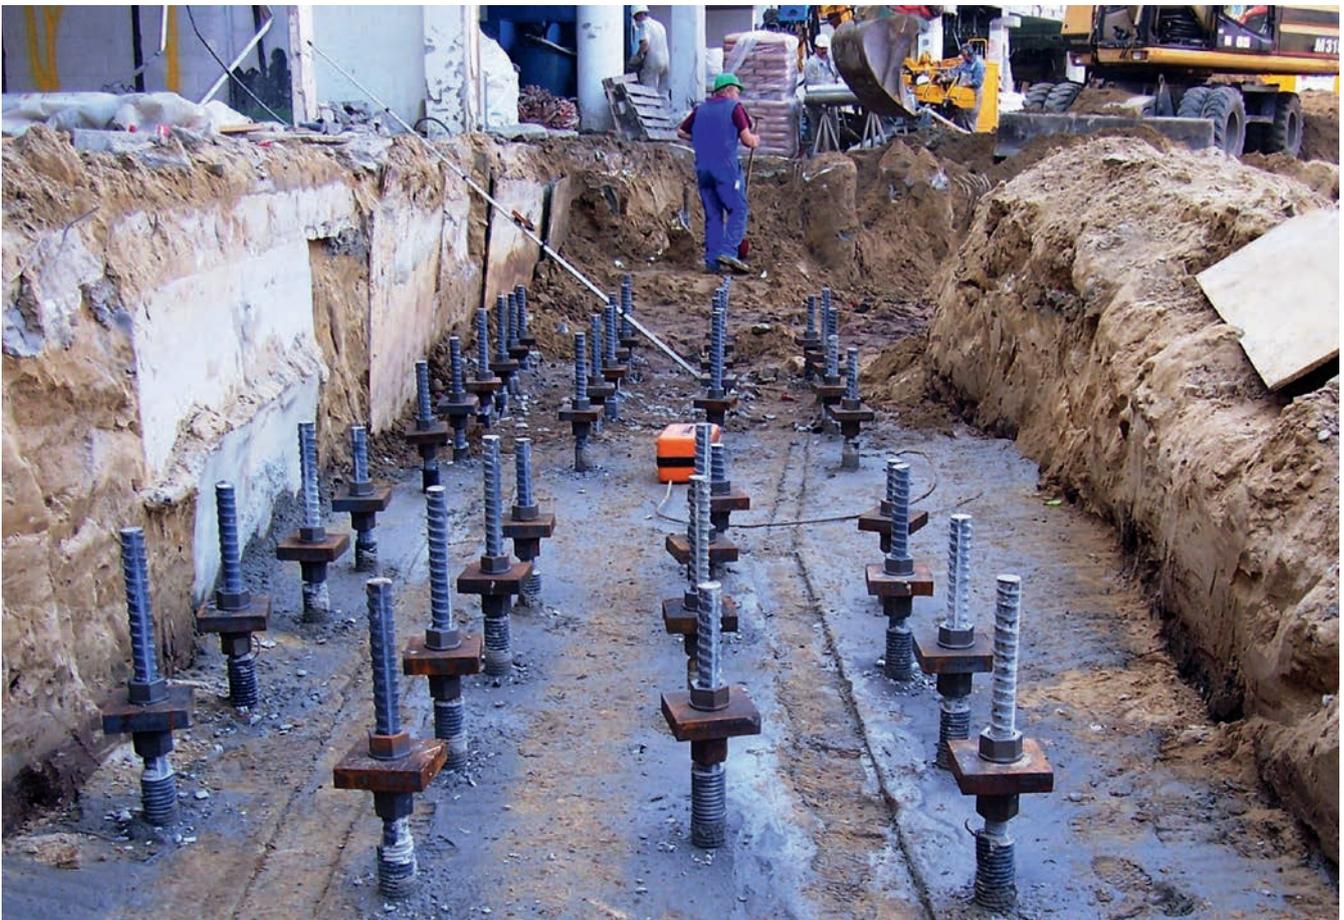
After finishing up the West stands in summer of 2009, the project was continued with similar reconstruction measures of the East tribune during season break in the following summer. Only this time around, we had to abide by an even tighter time schedule, which forced us to work at our productive capacity with up to three drill- and grout units – partially in double shifts – in very confined working conditions (see Image 1). In sum, we produced 461 micro piles with a total steel length of 6.500 m in only 17 days right on schedule. Meanwhile, demolitions works on existing tribunes as well as piling works with large diameters were being carried out in such close proximity to our machines that it took excellent planning and daily coordination on behalf of our client to pull this endeavor off without delay. Singular foundation slabs underneath the stands could only be reached and penetrated with one of our mini drill rigs. Image 2 depicts a block foundation with our fully mounted Gewi-pile heads sticking out.
